Manhole Inspection Summary

Manhole # S41C__066MH

Insp Date: **1/5/09 9:35 AM**

Location Address: **301 ORLEANS ST**

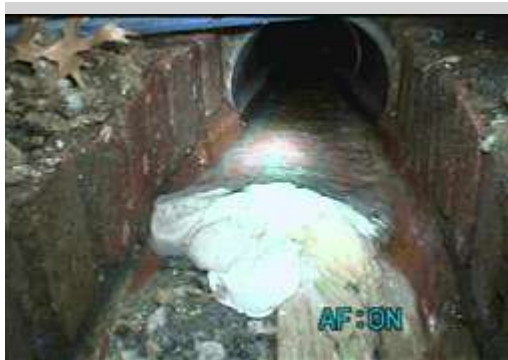
Miscellaneous

Condition: ☒ Sound ☐ Cracked ☐ Root Intrusion ☐ Deteriorated ☐ Leaks ☐ Debris

channel debris

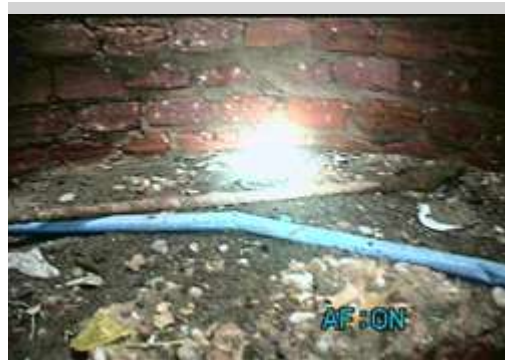
Defect 5

Condition: ☐ Sound ☐ Cracked ☐ Root Intrusion ☐ Deteriorated ☐ Leaks ☒ **Debris**

bench debris

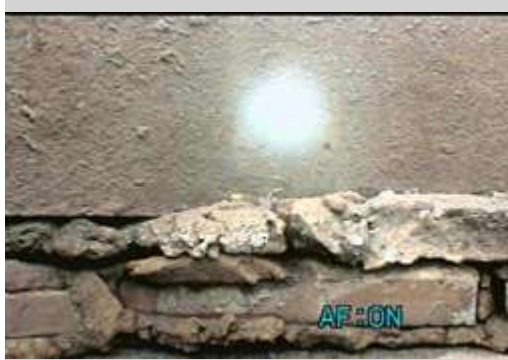
Defect 3

Condition: ☐ Sound ☐ Cracked ☐ Root Intrusion ☐ Loose Brick ☒ **Deteriorated**

chimney deteriorated

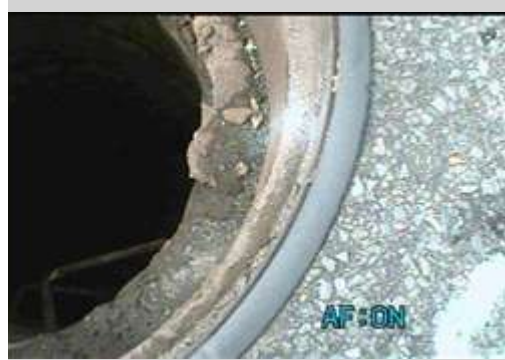
Defect 2

Offset: **3.5** (in.)

offset

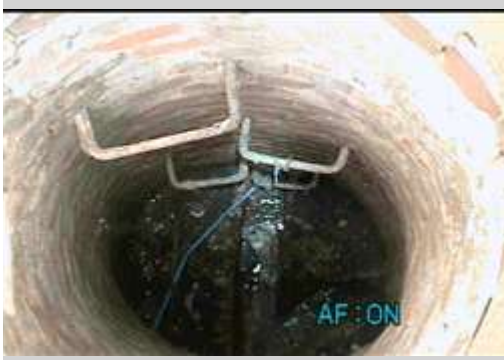
Defect 1

Count: **4** Missing: **0** ☒ **Corroded**

☒ **Evidence Of Surcharge** Depth: **4** (ft.) ☐ Active Surcharge Present

Corroded steps, surcharge evidence

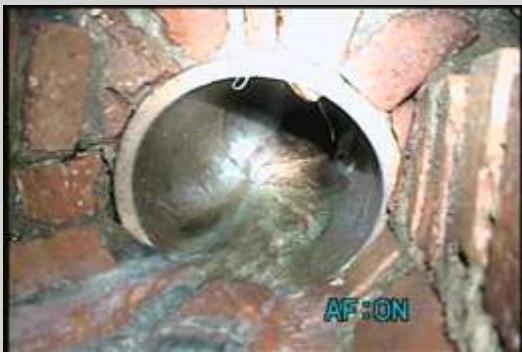
12 O'Clock Outflow

Pipe Height: **8.4** (in.) Rod and Bar (Angled)
Pipe Material: **Clay** ☐ Pipe Lined
Invert Depth: **10.07** (ft.) Flow Characteristics: **Slow**
Deposits: ☒ None ☐ Mud ☐ Gravy ☐ Debris ☐ Grease
Silt Depth: **0** (in.) Deposits Extent:
Infiltration: **None** Pipe Seal Cond: **Sound**

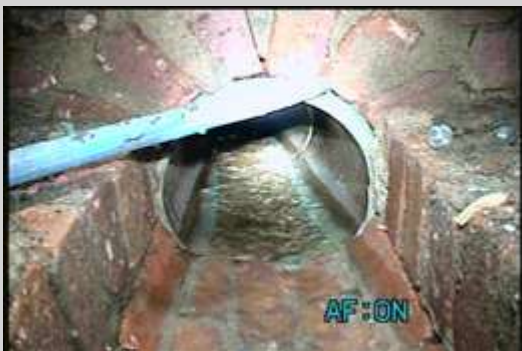
6 O'Clock Inflow

Pipe Height: **8.4** (in.) Rod and Bar (Angled)
Pipe Material: **Clay** ☐ Pipe Lined
Invert Depth: **9.27** (ft.) Flow Characteristics: **Slow**
Deposits: ☒ None ☐ Mud ☐ Gravy ☐ Debris ☐ Grease
Silt Depth: **0** (in.) Deposits Extent:
Infiltration: **None** Pipe Seal Cond: **Sound**

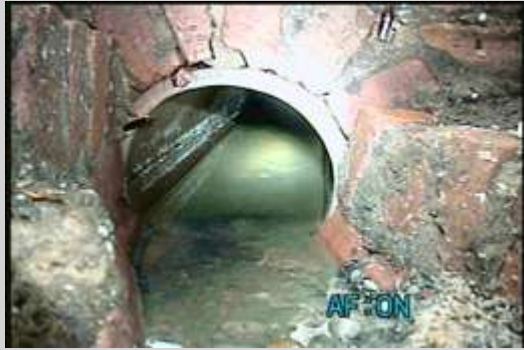
9 O'Clock Inflow

Deposits: ☐ None ☐ Mud ☒ **Sludge** ☐ Debris ☐ Grease

Silt Depth: **2** (in.) Deposits Extent: **Light**
